# Evaluation of Dowel Bar Inserter Practices in PCC Pavements with Magnetic Tomography Technology

Report MPMC-04

Final Report  
26-1121-4027-001

December 2016

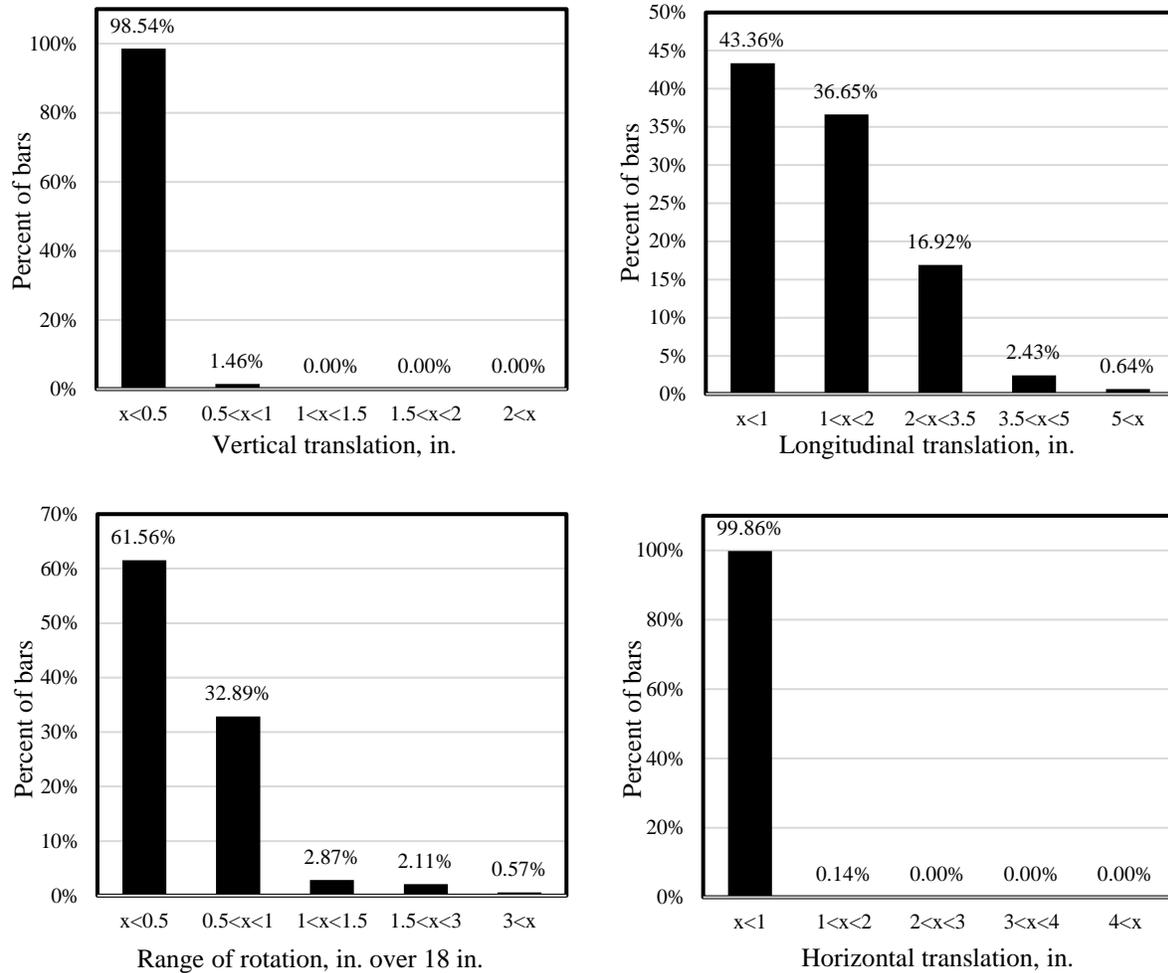
**Figure 3.1** Dowel misalignment values of Hooper project

Figure 3.1 shows the dowel positions for the 110 joints scanned in the US 275 “Hooper” project, which was completed in 2009. It can be seen that vertical and horizontal translation of the dowels is not a concern, while high longitudinal translation and rotation of the dowels is present. Approximately 20% of the dowels fall outside acceptance criteria for longitudinal translation (2.0-2.1 inches), and 1 joint has to be rejected based on ACPA and FHWA rejection criteria due to average longitudinal translation of 5.1 inches. However, it should be noted that no distress was observed during the field performance measurement of this joint.

As for dowel rotation, 6% of the dowels fall outside acceptance criteria and 3% of the bars should be rejected based on ACPA and FHWA criteria. Many of the dowels with high values of rotation were in the same joint that should be rejected due to longitudinal translation. Three missing dowels were also identified on separate joints in the Hooper project. All of the missing dowels lay in the vehicle wheel-path and thus the load distribution among dowels is expected to be adversely affected.

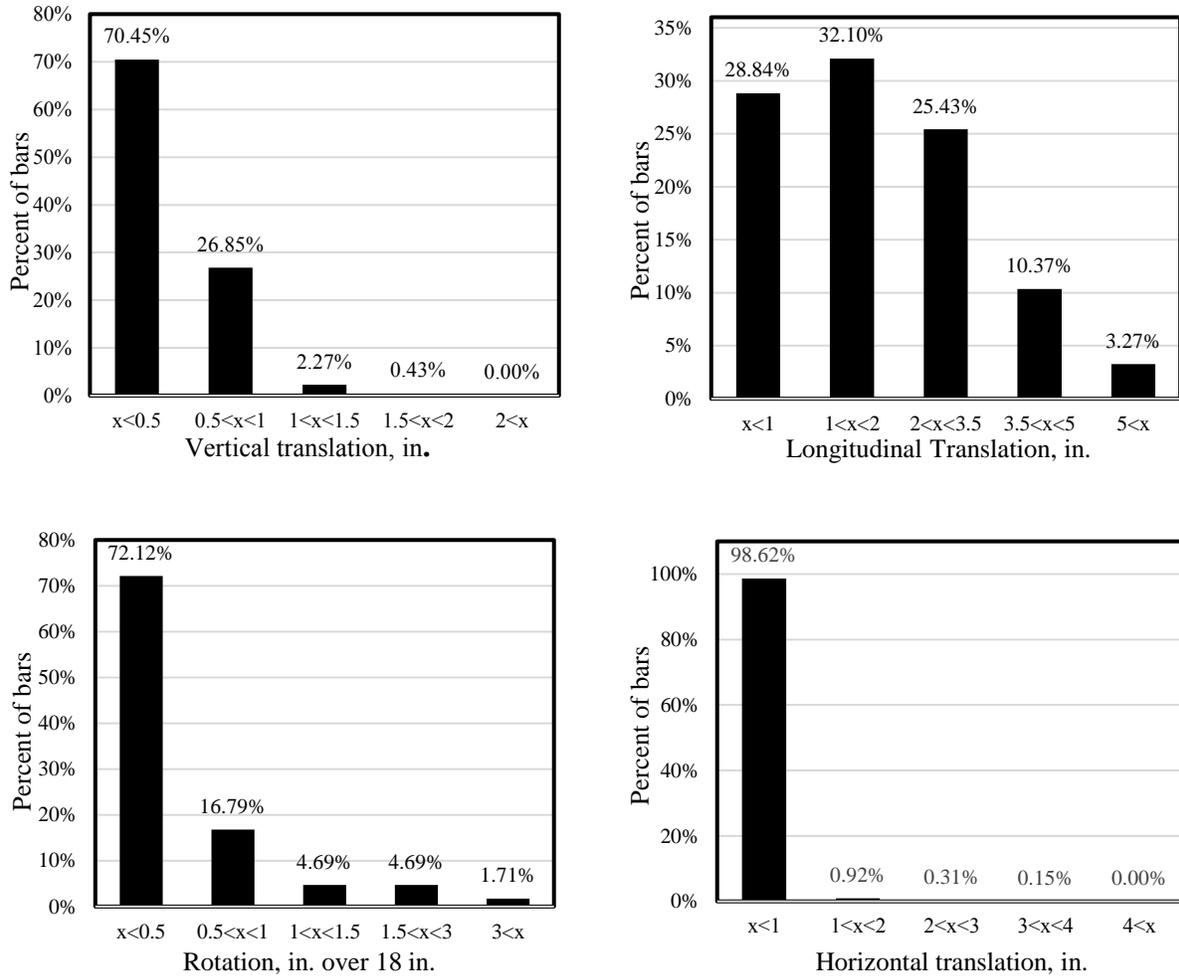
**Figure 3.2** Dowel misalignment values of Kimball project

The dowel misalignment values of the 55 joints in SR 71 “Kimball” project can be seen in figure 3.2. Compared to the previous project, higher longitudinal and vertical translation of the dowels can be seen. Only 60% of the dowels showed acceptable longitudinal translation values, and 3 joints should be rejected based on ACPA and FHWA criteria. However, 97% of dowels presented acceptable vertical translations, and the other 3% still have sufficient concrete cover based on all criteria. Regarding rotational misalignment, four joints will be rejected based on the criteria of all agencies, two of which also had excessive longitudinal translations.

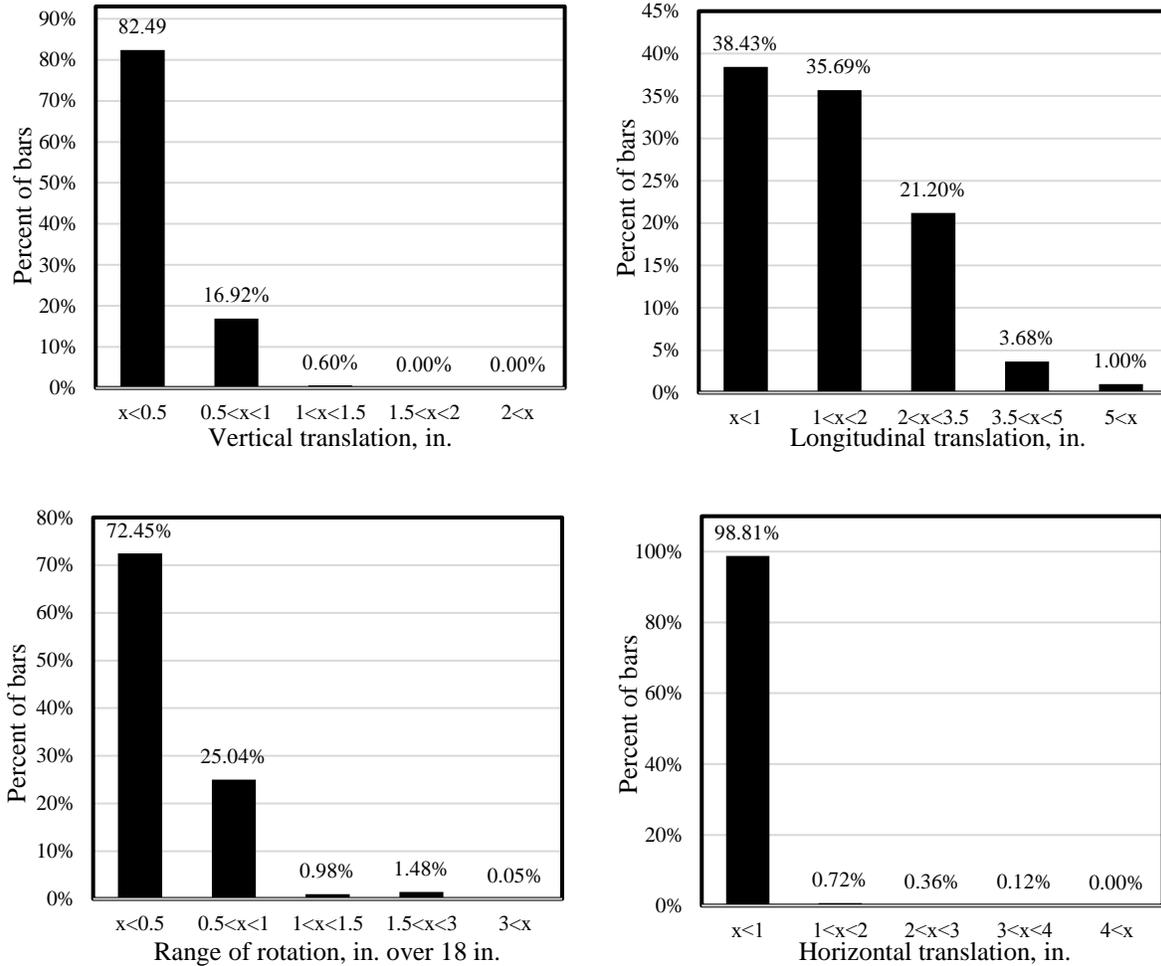
**Figure 3.3** Dowel misalignment values of Roscoe project

The dowel misalignment values of the I-80 project “Roscoe”, and the US 275 project “Norfolk” can be seen in figures 3.3 and 3.4. The number of joints scanned for the projects were 155 and 175, respectively. The east and west directions of Norfolk were completed in 2005 and 2009 respectively, while Roscoe was completed in 2012. Similar to previous projects, both Norfolk and Roscoe showed acceptable vertical and horizontal translations. The dowels in Roscoe project have higher longitudinal translation with 35% of dowels falling outside acceptance criteria of national agencies , and 3 joints that have to be rejected, while Norfolk has 12% of dowels outside

acceptance criteria and 3 joints that need corrective action. It can be noted that field investigation showed zero to 1 mm. faulting for those three joints.

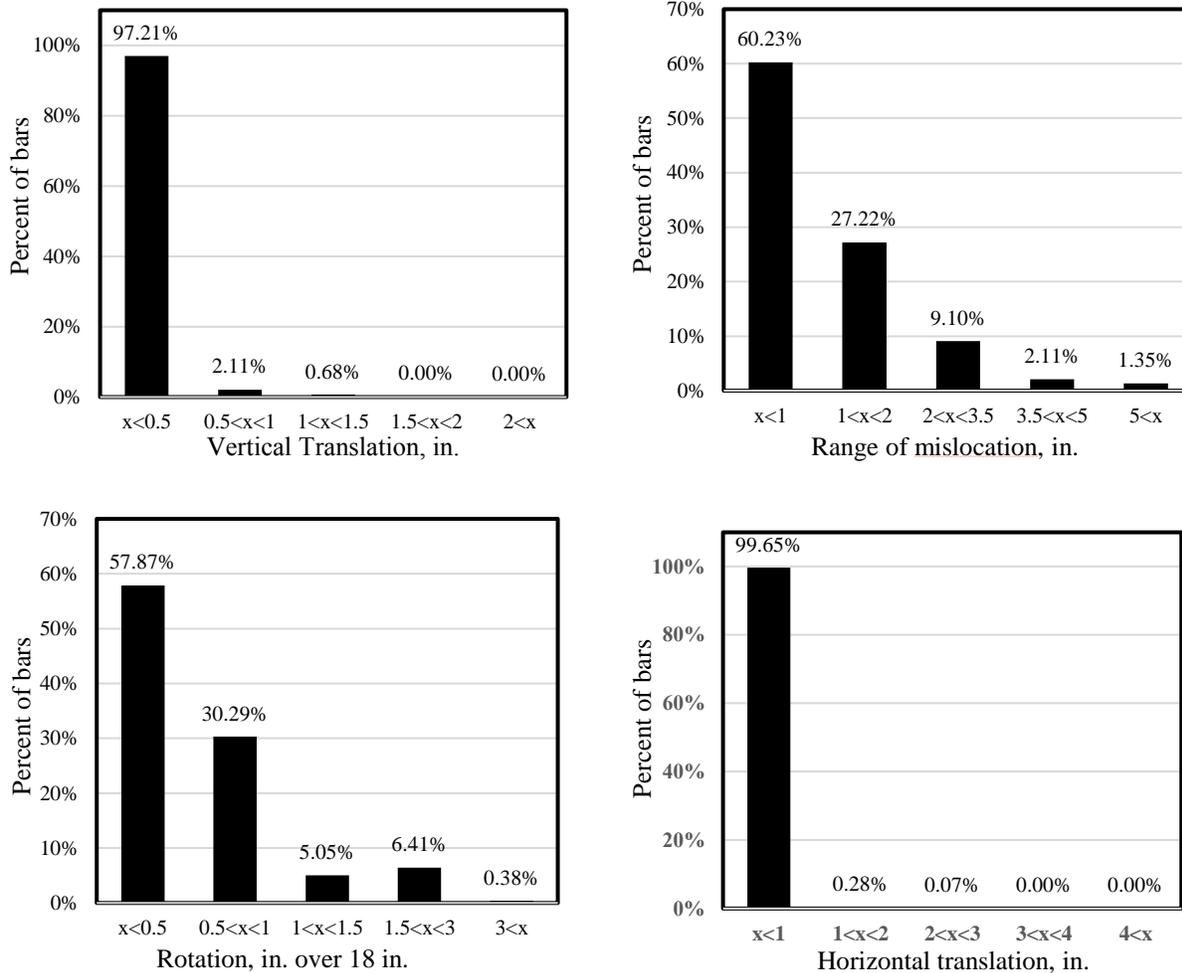
**Figure 3.4** Dowel misalignment for Norfolk project

The Norfolk project has higher rotational misalignment compared to Roscoe, with 12% outside acceptable tolerances compared to less than 3% for Roscoe. Seven percent of Norfolk joints fall outside the rejection criteria of FHWA and ACPA, compared to less than 2% for Roscoe.

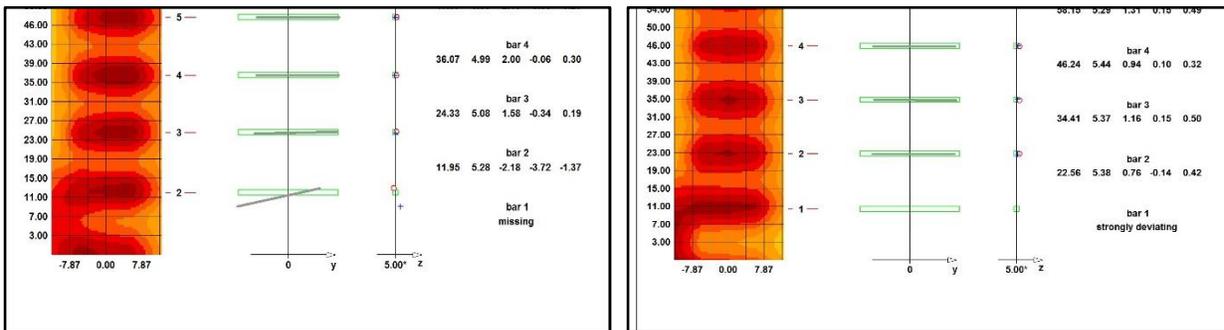
**Figure 3.6** Tie bar interference

Interference from tie bars were observed in approximately 20% of the joints in the Norfolk project. Figure 3.6 shows examples of the interferences in two of the joints. Such joints have been excluded from the data investigation and analysis due to high measurement errors, which make the results unreliable.

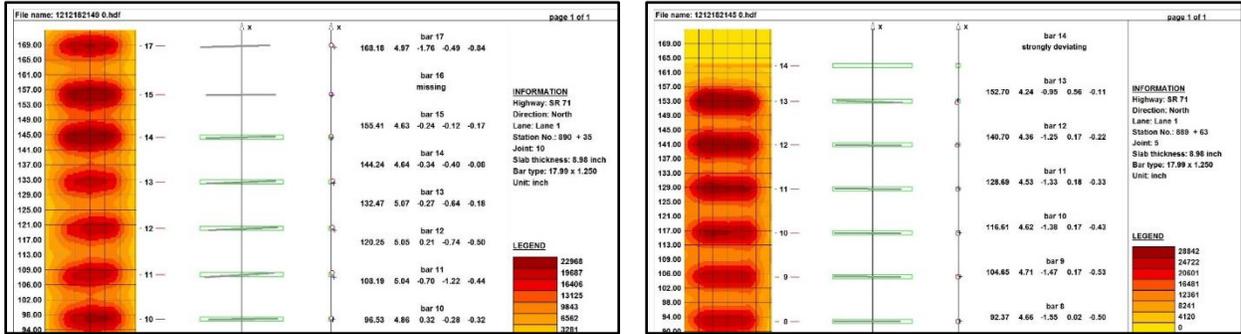
Figure 3.7 Erroneous dowel identification by MagnoProof software

A few instances of the MagnoProof software mistakenly identifying the dowels as missing or strongly deviating was also encountered during data investigation. Examples of such joints are shown in figure 3.7. Such occurrences, together with the existence of foreign metals that can affect

the results, show that the results provided by the software are not always correct, and manual inspection of individual joint contours is necessary for a reliable quality assurance approach.

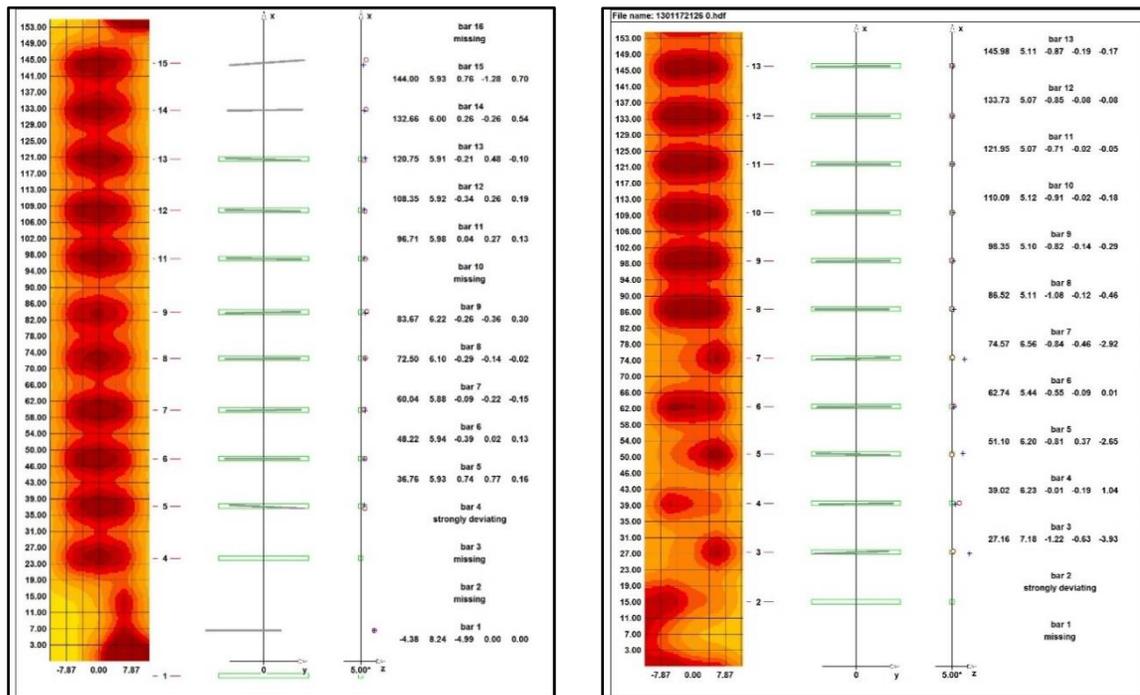
**Figure 4.1** Examples of joints excluded from analysis

Some of the joints in Norfolk project had dowel misalignments that could not be captured by typical misalignment categories, and thus these joints were not included in the data analysis task. Examples of two joints are presented in figure 4.1. From the signal intensity contour, it can be seen that some of the dowels in the joint are completely shifted and have lost their effectiveness. It is worthy to note that the joints in this figure had faulting values of 2 to 3 mm, which were among the highest faulting values observed on the Norfolk project. In spite of that, the

misalignment values reported by the MIT Scan-2 device does not capture the condition of the joint. Therefore, these joints have not been included in the analysis.

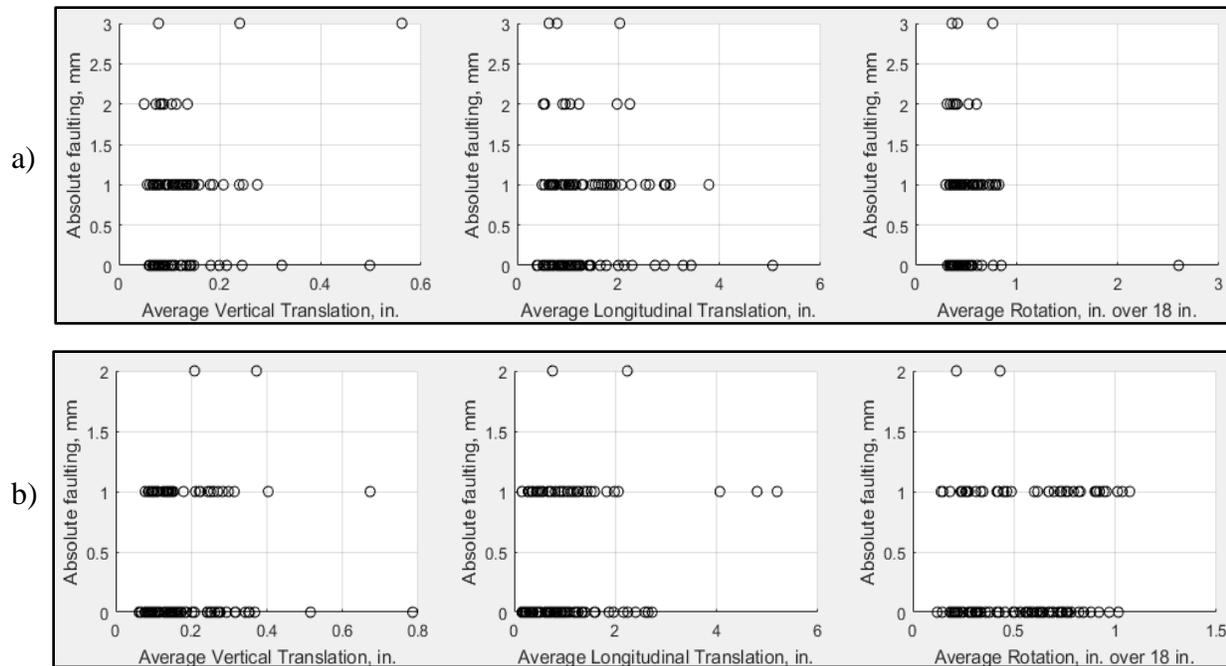
**Figure 4.2** Faulting as a function of average dowel misalignment for (a) Hooper and (b) Norfolk

In order to analyze the effect of longitudinal translation, vertical translation, and dowel rotation on faulting at joints, faulting-misalignment graphs were developed for Hooper and Norfolk projects. Figure 4.2 shows the faulting value of each joint as a function of the average misalignment value of the joint dowels. If there is a relation between faulting and the extent of misalignment observed in the field, a trend is expected in the graphs. However, no such trend is visible, and it can be seen that higher faulting values (>2mm) occur at all ranges of dowel misalignment, which means that the high value of faulting is likely caused by factors other than dowel misalignment.
