## Field Demonstration of Magnetic Tomography Technology for Determination of Dowel Bar Position in Concrete Pavement

1. Report No. FHWA/VTRC 06-R40	2. Government Accession No.	3. Recipient's Catalog No.	
4. Title and Subtitle Field Demonstration of Magnetic Tomography Technology for Determination of Dowel Bar Position in Concrete Pavement		5. Report Date June 2006

June 2006  
VTRC 06-R40

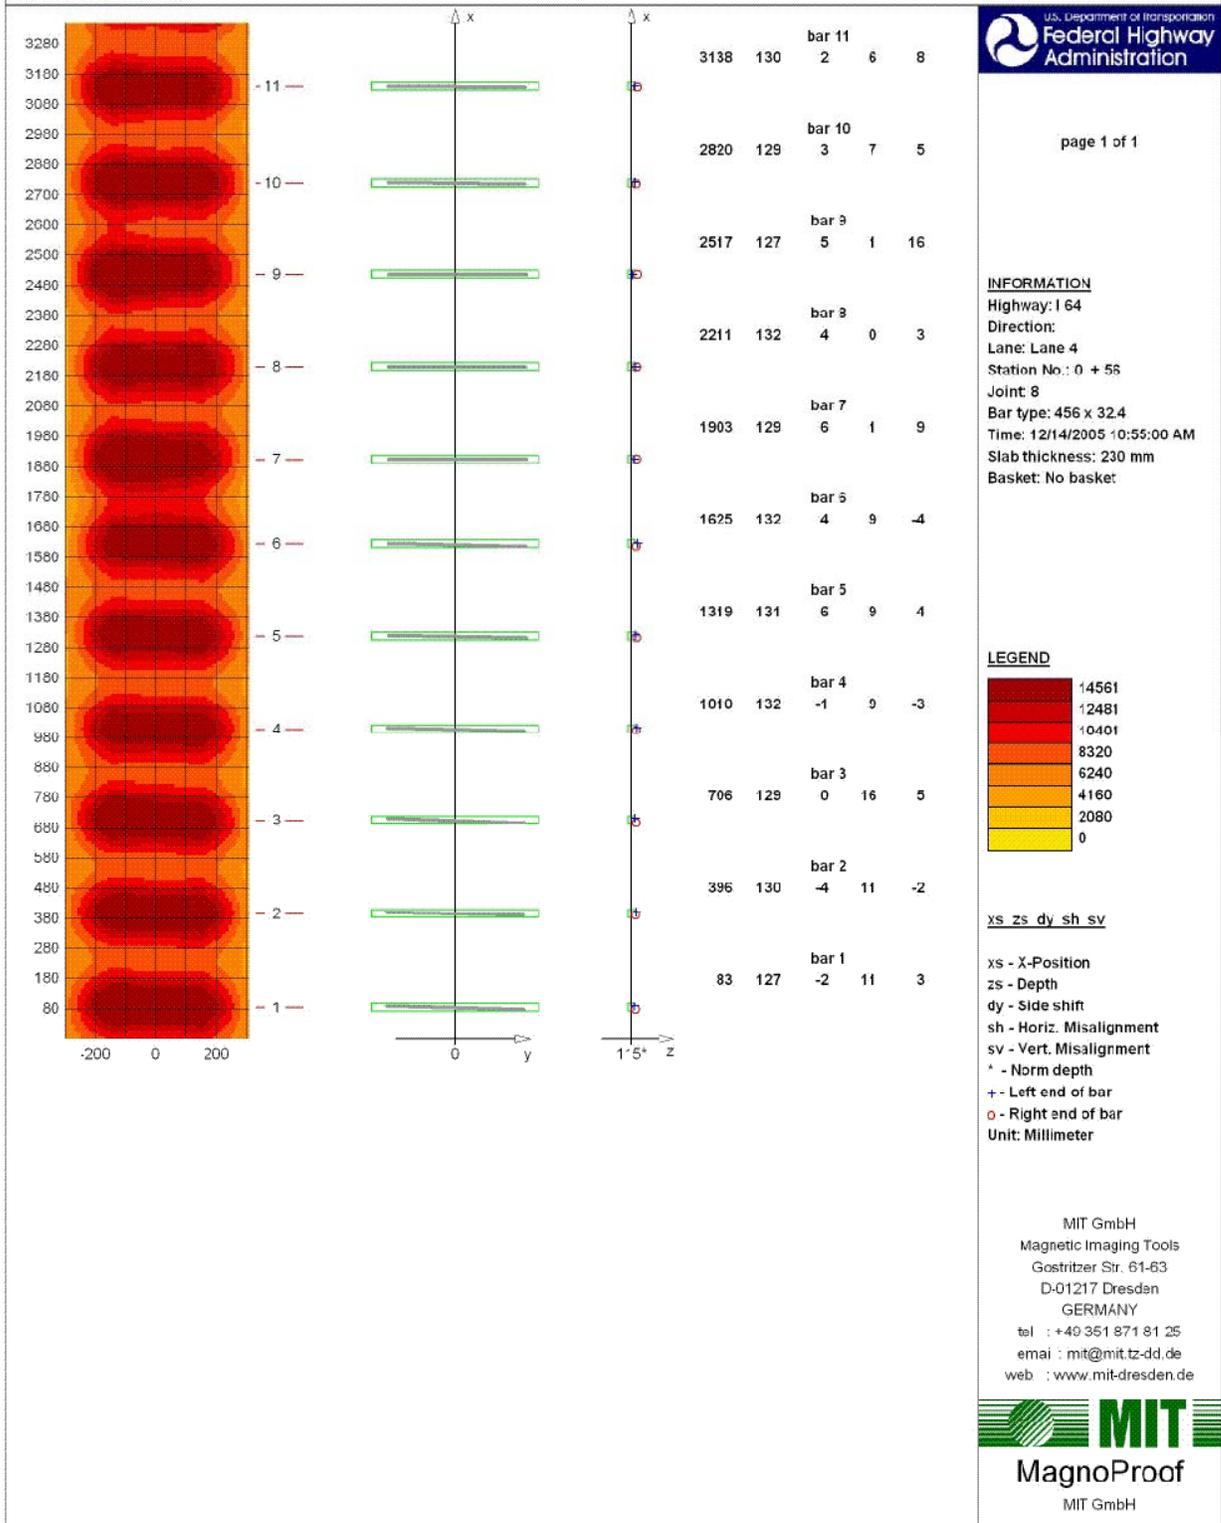
Figure 5. Typical Graphical Output from Laboratory Analysis of Joint 8 on I-64

The third column shows the elevation of the two ends of the bar with respect to the mid-depth of the slab. The text description of these measurements is included on the same output. For example, the following are the measurements for Bar 4:

1. X-position = 1010 mm (398 in) indicates that the location of Bar 4 is 1010 mm (398 in) from the start point of the scan (i.e., the edge of the pavement); it is the point where the actual bar intersects the transverse joint
2. Depth = 132 mm (5.2 in) from the concrete surface
3. Side shift = -1 mm (0.04 in), middle of the dowel bar is 1 mm (0.04 in) left of the transverse joint (positive value indicates the shift is on the right of the joint)
4. Horizontal misalignment = 9 mm (0.35 in) means Bar 4 is skewed 9 mm (0.35 in) from one end to the other in a plan view (clockwise is positive)
5. Vertical misalignment = -3 mm (0.12 in), elevation of right end is 3 mm (0.12 in) higher than left end (positive would indicate right end is lower than the left).

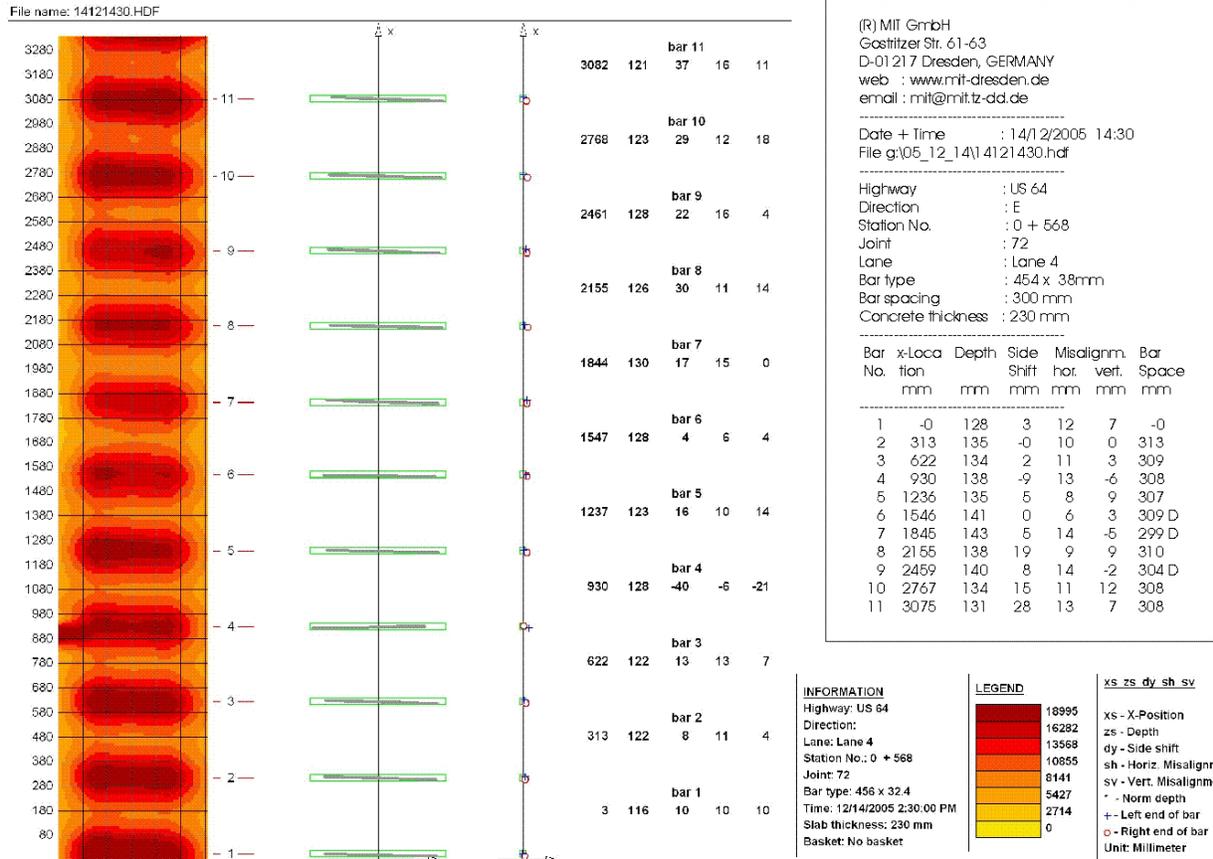
Figure 6. Comparison of Field and Laboratory Data Analysis (Joint 72 on I-64)

The dowels on I-64, as mentioned earlier, were placed on wire baskets. From the well-defined contour map, it seemed that shipping wires for the dowel baskets were cut before paving for all joints. During the field measurement, the wrong-size dowel bar (38 mm, 1.50 in) was used as an input on the MIT Scan-2, but it was later corrected (32 mm, 1.25 in) for laboratory analysis. This correction resulted in a significantly shallower (about 10 mm) depth for all bars, as shown in Figure 6. Another interesting observation in Figure 6 is the influence of a foreign metal on Bar 4. Although the signal contour map is clearly showing the presence of a foreign metal near Bar 4, there is no evidence in the field results (output). A total of 82 joints were scanned on I-64, and only 2 joints (Joints 58 and 80) did not produce meaningful results: 97.6 percent of joints provided useful information. Although Joint 58 gave a printout (text file) in the field showing the presence of only a few bars, further analysis with MagnoProof was inconclusive. A device error was suspected for both of these cases.

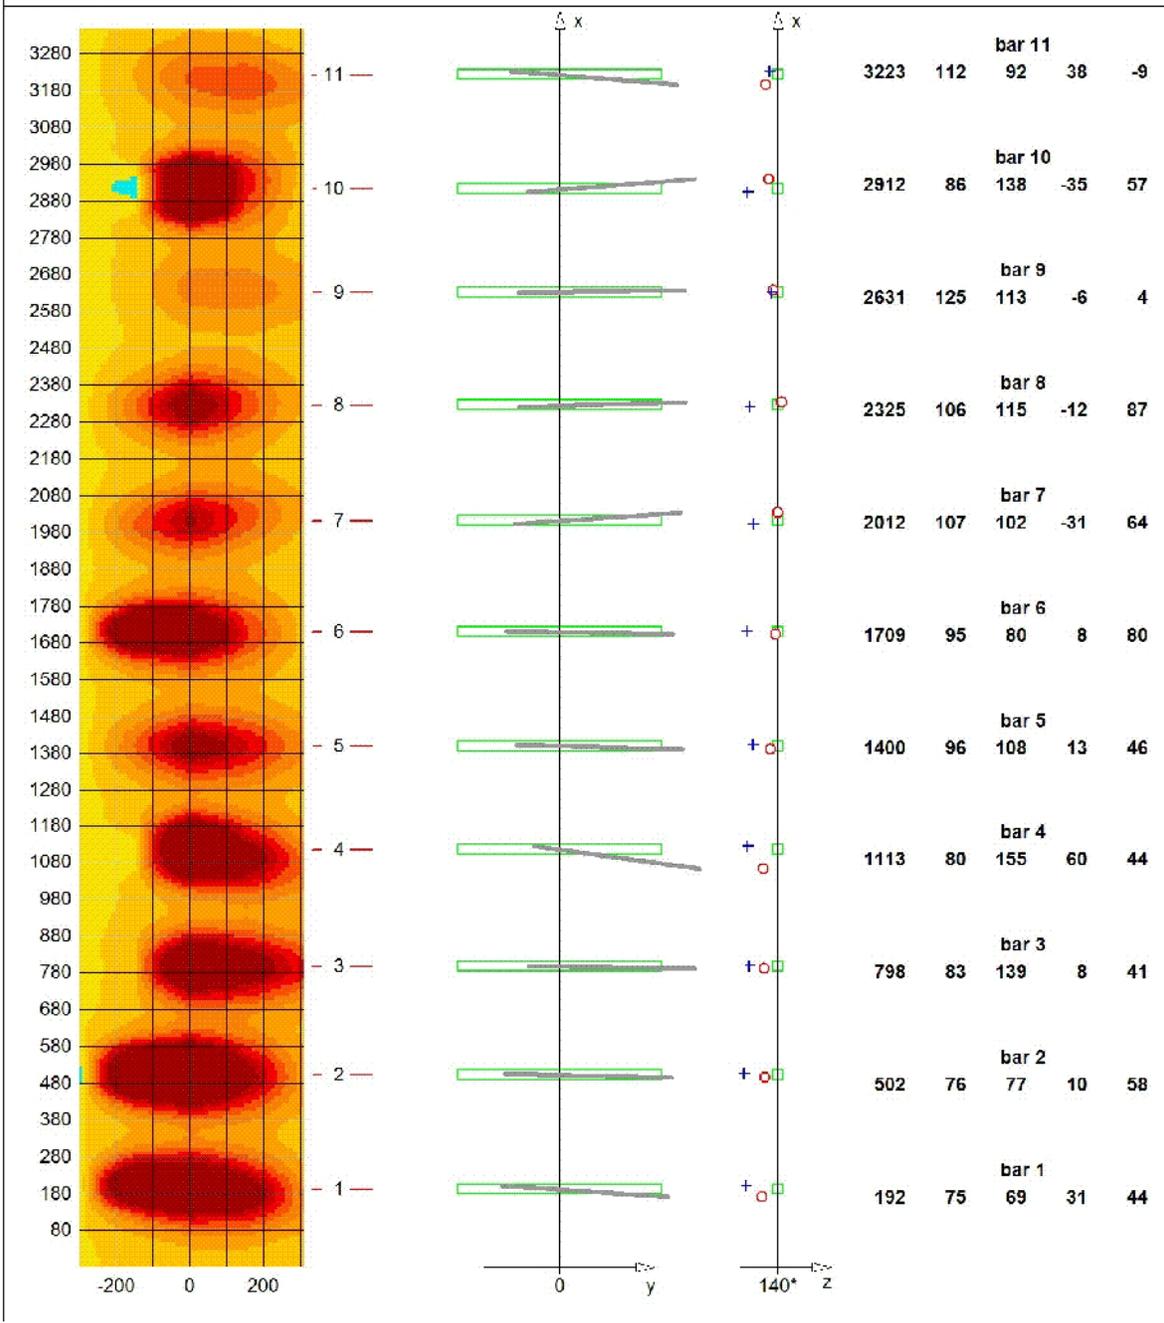
Figure 7. Results from Joint 54 on I-66

Joint 54 on I-66 had an exposed dowel bar near the left wheel path of the travel (outermost) lane. During the scan, MagnoNorm was unable to complete the analysis and no field results were obtained. Therefore, MagnoProof was used to analyze the data, and the bar locations were found as shown in Figure 7. There were 11 bars, and all of them show excessive misalignment. The exposed dowel is identified as Bar 10 with the “splotch” between 2880 and 2960 (blue in color) on the exposed side. The depths for all bars were shallow and vary from 75 to 125 mm (3.0 to 4.9 in). The side shifts were also excessive, with a range of 69 to 155 mm (2.7 to 6.1 in). Again, both the vertical and horizontal misalignments were excessive, with a value as high as 87 mm (3.4 in). So there were obvious reasons for the device not being able to accomplish data analysis in the field. Although MagnoProof, with the higher computing power, was able to provide a qualitative picture of the dowel bar locations, the results might still be

unreliable. It is important to note that dowels were mechanically inserted for this section of highway. Field verification was planned for this location and is discussed later in the report.

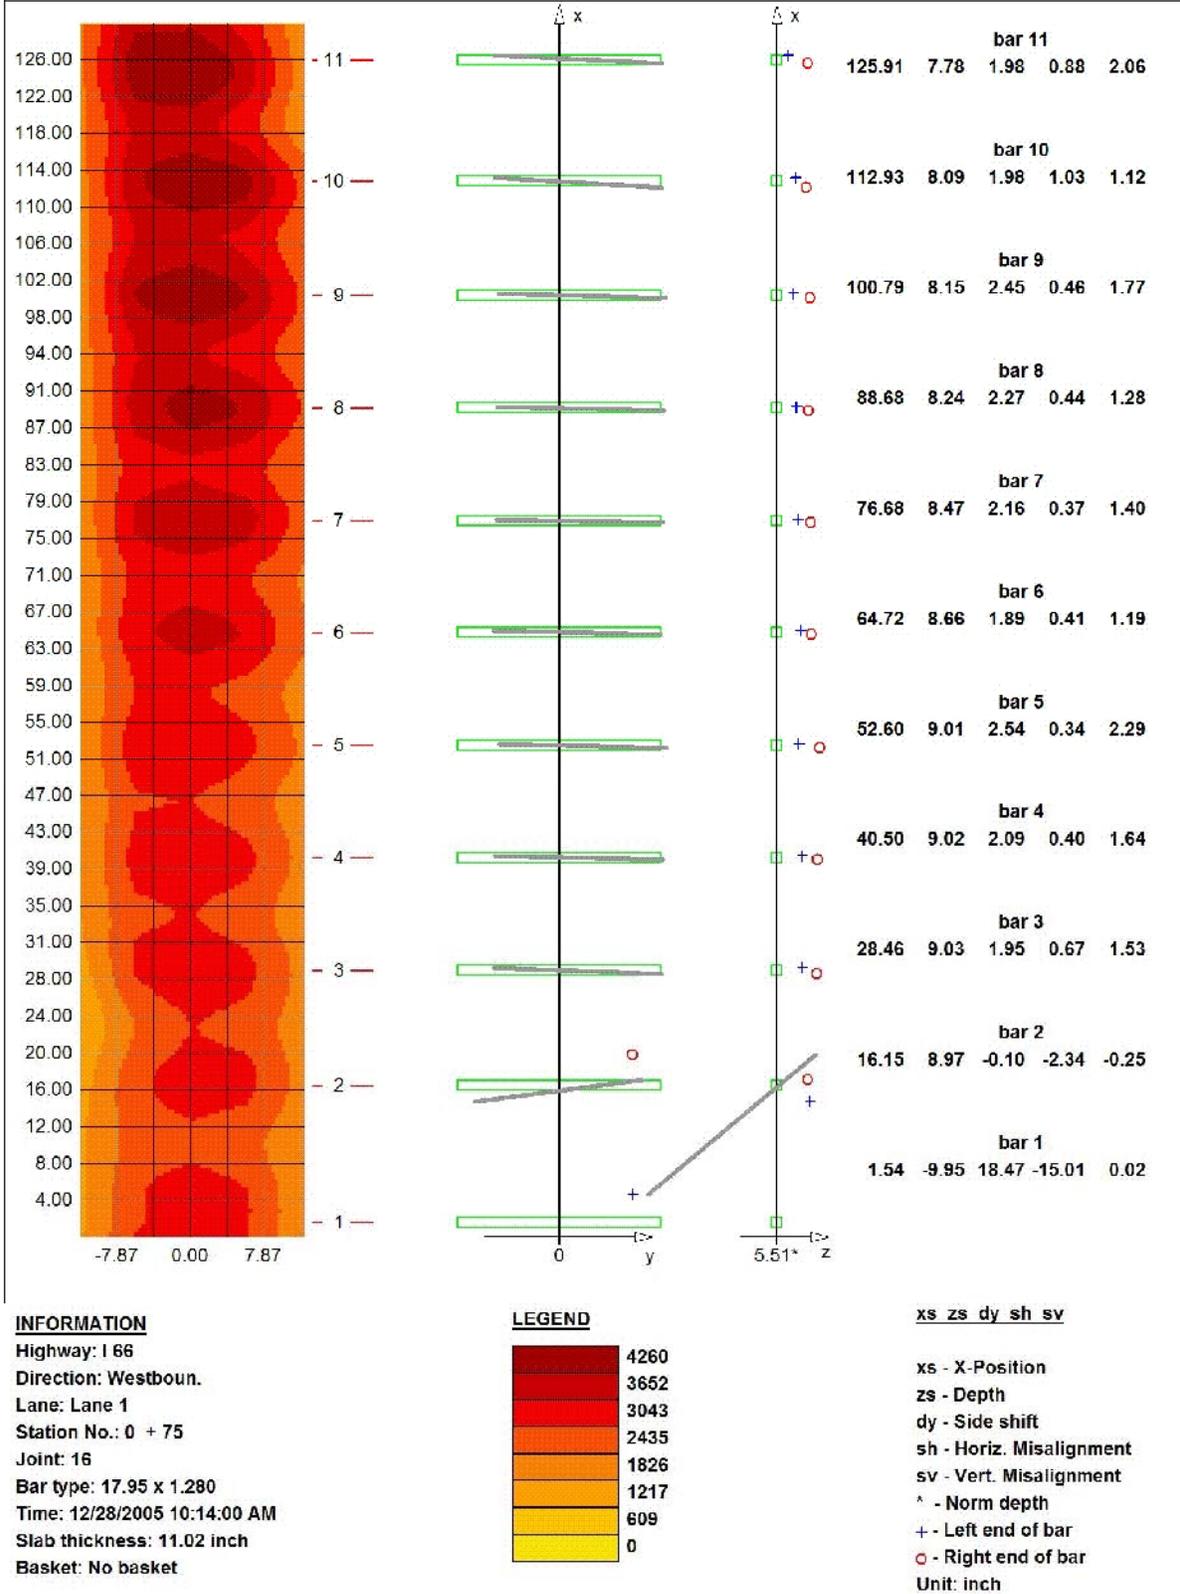
Figure 9. Laboratory Data Analysis Results for Joint 16 on I-66

Another joint (Joint 16) on I-66 had dowel bars too deep into the concrete. An example of the field output, shown in Figure 8, was obtained for this joint, and all 11 bars in the outmost travel lane were found to be deeper than 200 mm (8 in). These bars were also mechanically inserted using the DBI. Further analysis with MagnoProof revealed similar depths but showed a significant instability of the results leading to a completely different output with each successive run of the program. For many occurrences, it was not even possible to complete the analysis because of floating point over flow error; in one run, it showed only a few bars. Results are presented in Figure 9 from one successful run. Again, all bars except one are deeper than 200 mm (8 in). The data from this joint were unreliable and did not allow analysis because of the depth of the bars.

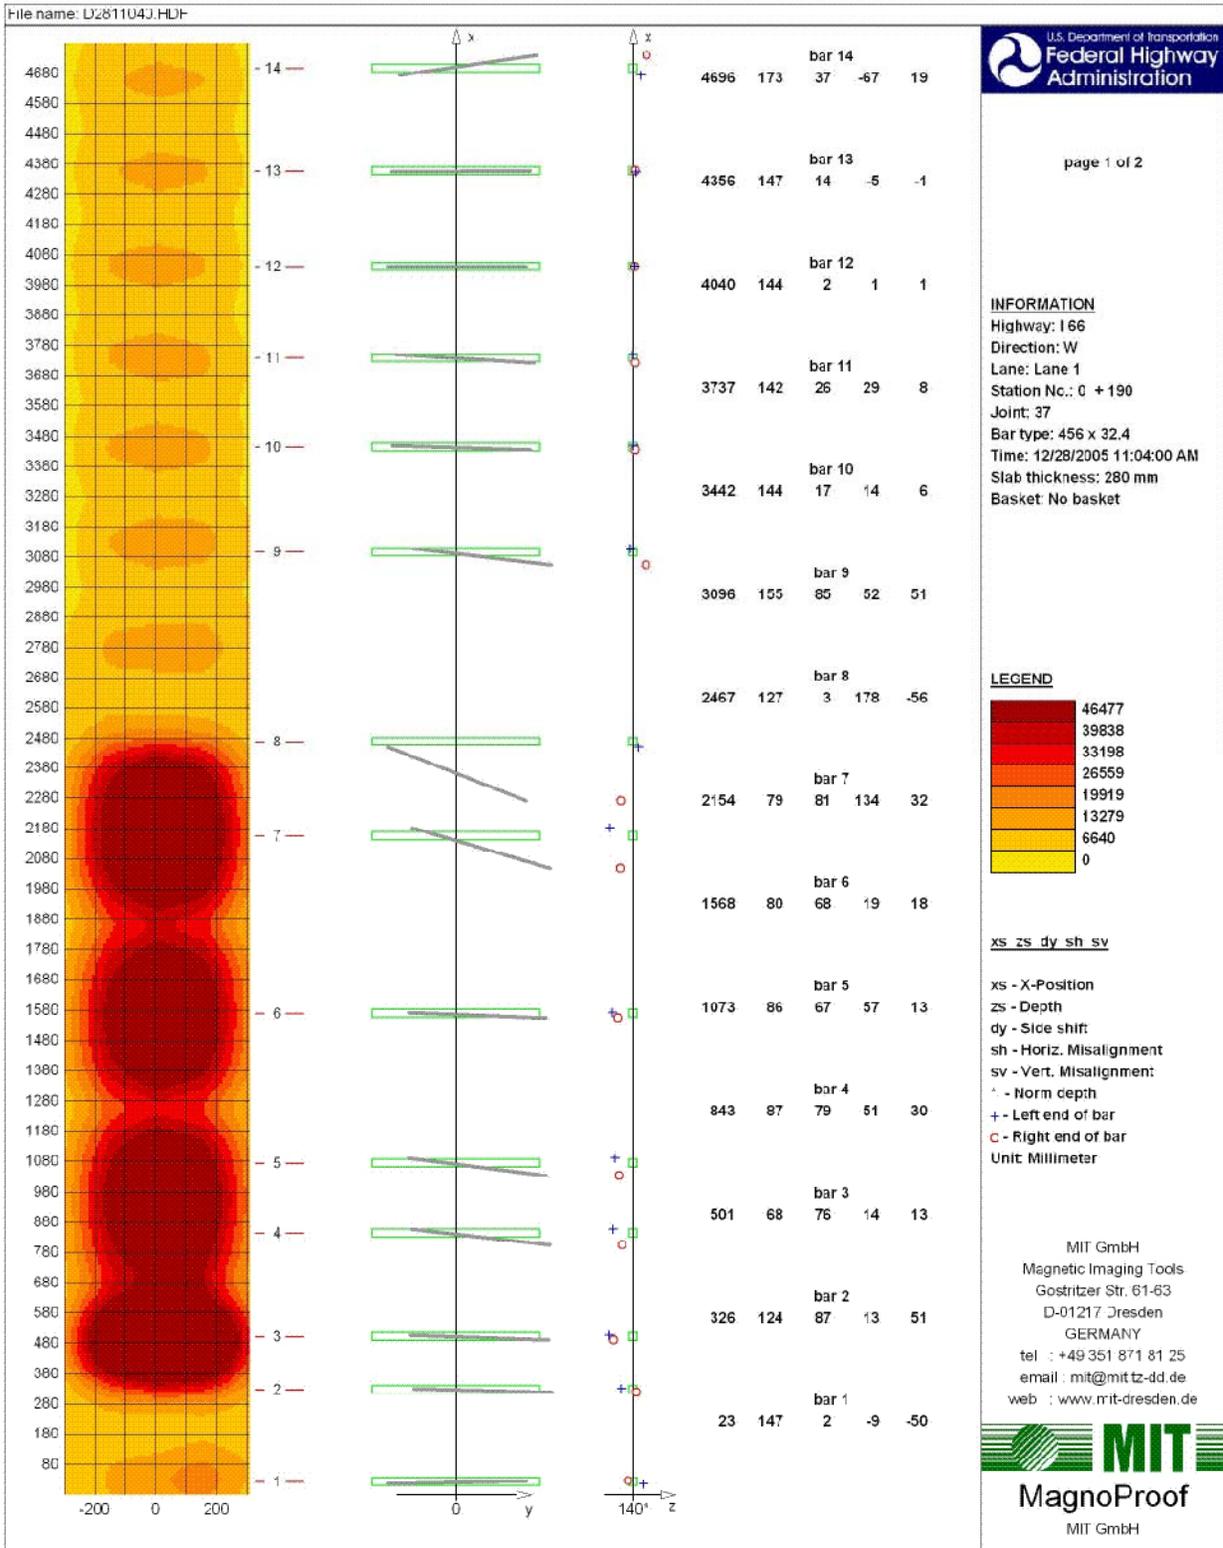
Figure 10. Signal Looping for Joint 37 on I-66

1. There was a strong magnetic signal loop surrounding several bars in the shoulder where dowels were on a basket. One such loop is shown in Figure 10 for Joint 37. Either the shipping wire was not cut or the epoxy insulation on the dowel itself might have been broken/abraded. When bars are too shallow and closely spaced, similar loops may be shown.
2. The dowel bars near the left wheel path of the outer travel lane are too deep and have excessive side shift. Although it was possible to scan most joints successfully, this trend was evident for many joints.
3. The end bars were only partially scanned.
4. Foreign metal was present in one or two cases.
5. For one joint, one dowel bar was exposed and several others were severely misaligned along with being at a low depth (<100 mm, < 4 in).
6. For one joint, (Joint 16), all the bars were deeper than 200 mm (8 in).

In addition, signal looping was evident in 13 joints in the shoulder. Although data analysis was possible for all of them, the results were unstable (changing values) with every run of the program, especially near the loop.

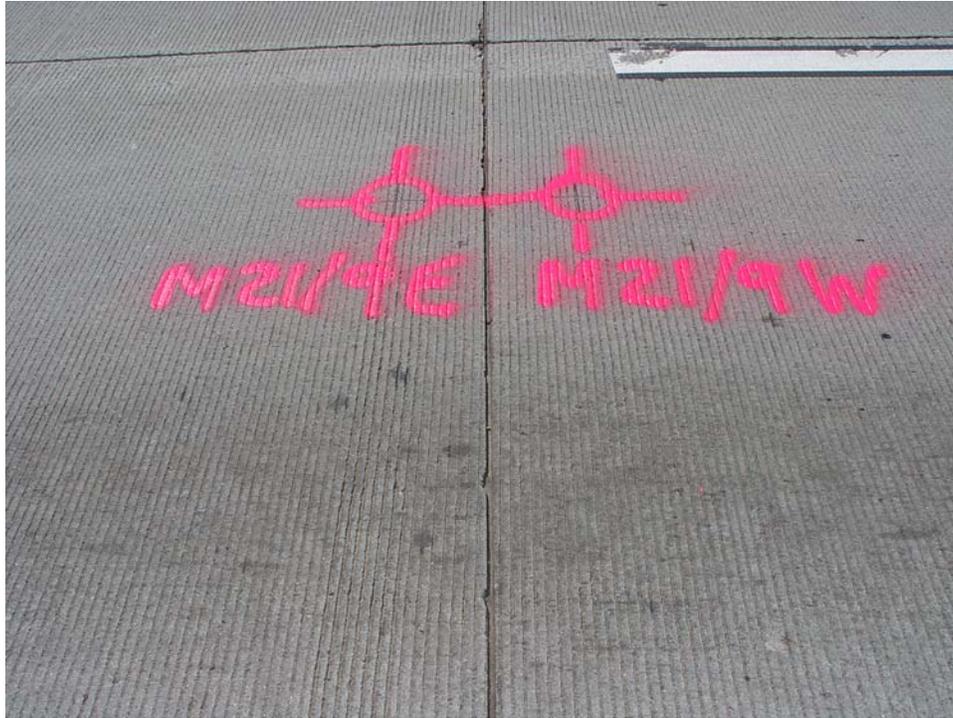
**Figure 11. Field Marking of Dowel Bar Near Joint 21 on I-66**

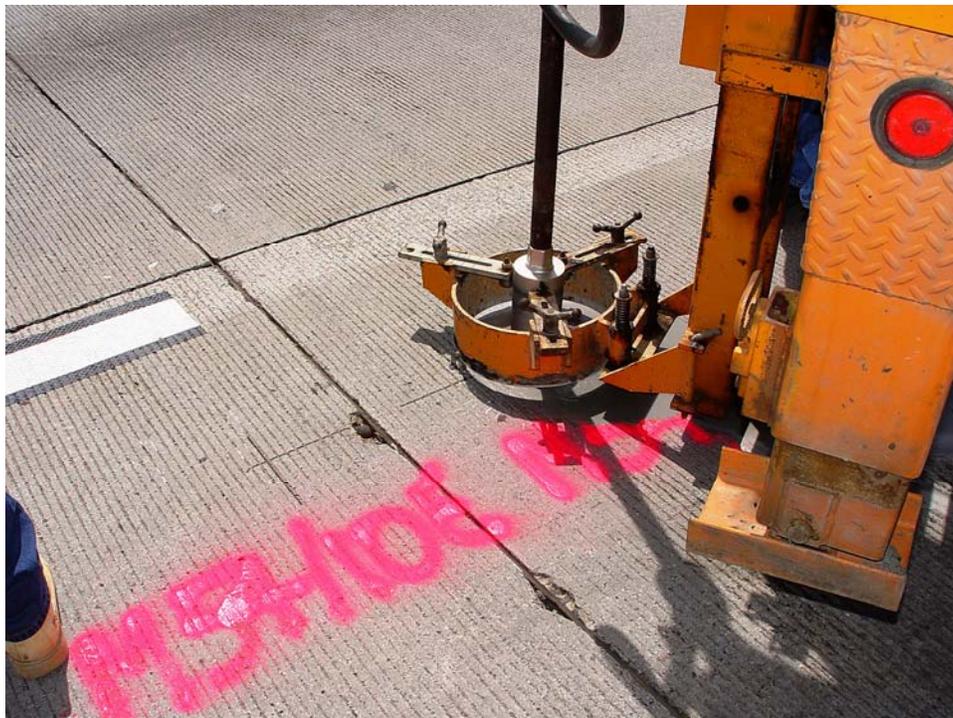
**Figure 12. Field Coring Operation Near Joint 54 on I-66**

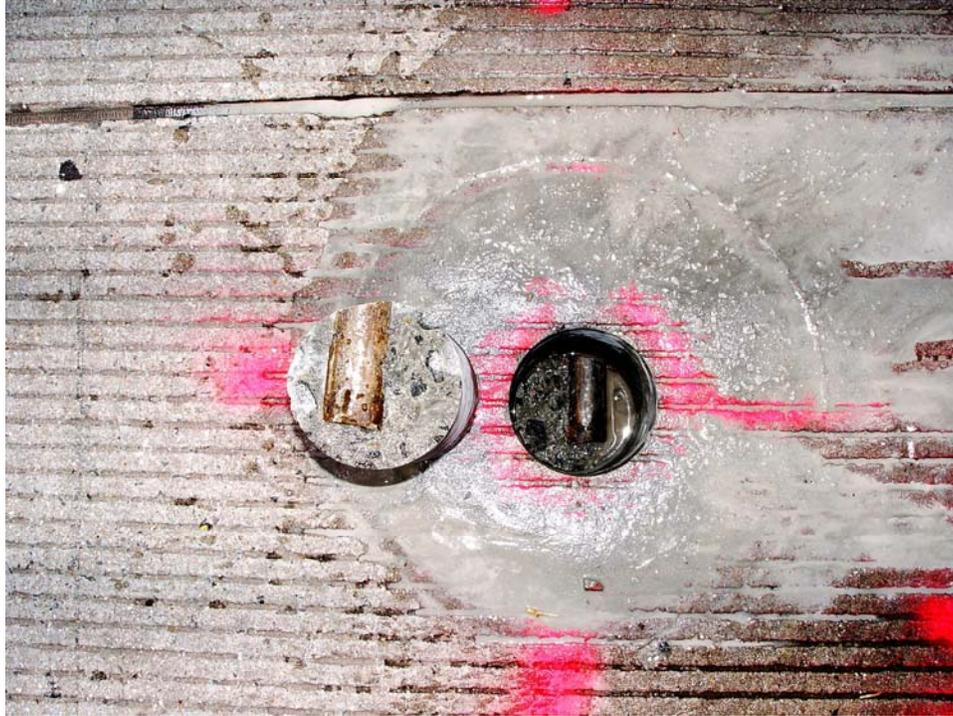
**Figure 13. Field Core and Dowel Bar Near Joint 43 on I-66**

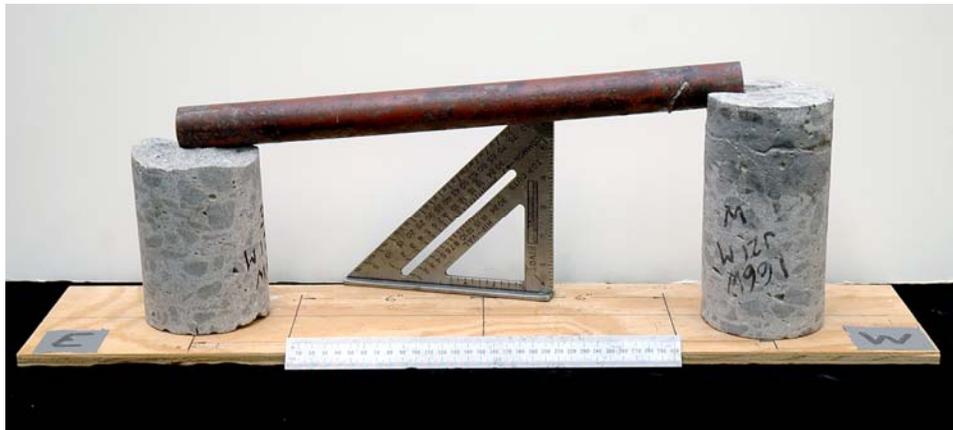
Of these nine bars, only one bar did not have any signal interference: Bar 9 of Joint 21 on the I-66 travel lane (Table 4). The location of this bar was about 12.5 mm (0.5 in) off the actual location. The distance measurements in the field might have contributed to this error. All other parameters were within 10 mm (0.4 in), with a range of 1.0 to 9.5 mm (0.04 to 0.37 in).

**Figure 14. Laboratory Recreation of Dowel Bar Orientation for Dowel 9 of Joint 21 on I-66**
