Public Roads

Publication Number: FHWA-HRT-05-006

Where the Dowel Bars Are

A new quality-assurance tool could help engineers improve the performance of concrete pavements.

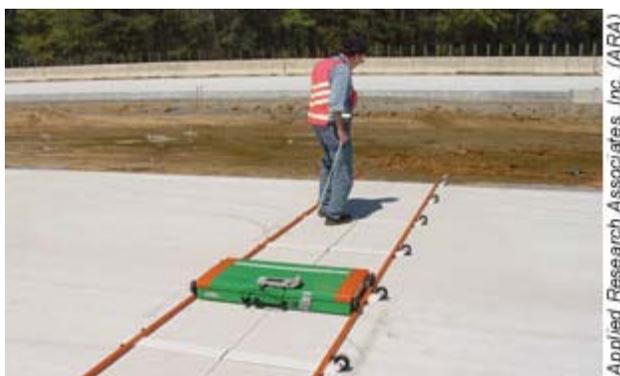
A worker is pulling the MIT Scan-2 scanning device across a joint in a new pavement to measure the alignment of the dowel bars in the concrete.

The MIT Scan-2 system consists of a sensor unit encased in a green box, an onboard computer that controls the testing process and records data, and a special plastic rail system that guides the unit along the joint to be scanned. During testing, the device emits a weak, pulsating magnetic signal and detects a transient magnetic response signal induced in the metal dowel bars. Employing the methods of tomography, the user is able to determine the position of a bar by taking a cross section mathematically to obtain useful information such as the bar’s orientation in the vertical and horizontal planes.

To use the device, an engineer enters pavement information, such as the type of dowel, slab thickness, and other data, into the onboard computer. The engineer then places the rails along the joint and slowly pulls the unit by hand over the length of the joint. The testing takes about 1 minute per joint, and up to three lanes can be tested at a time. In an 8-hour day, a two-person crew can test 200 or more joints. In addition, the tool can run continuously for up to 8 hours on one battery charge.

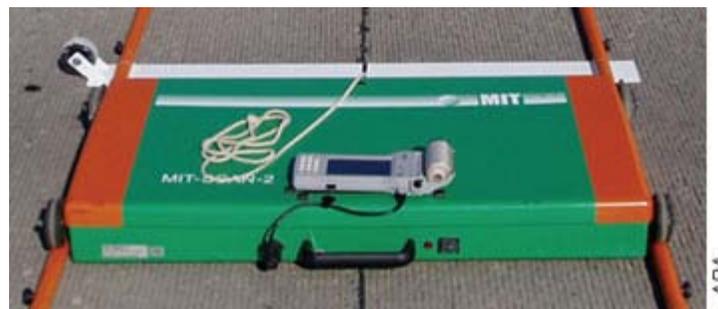
A closeup of the MIT Scan-2 resting on a new concrete pavement.

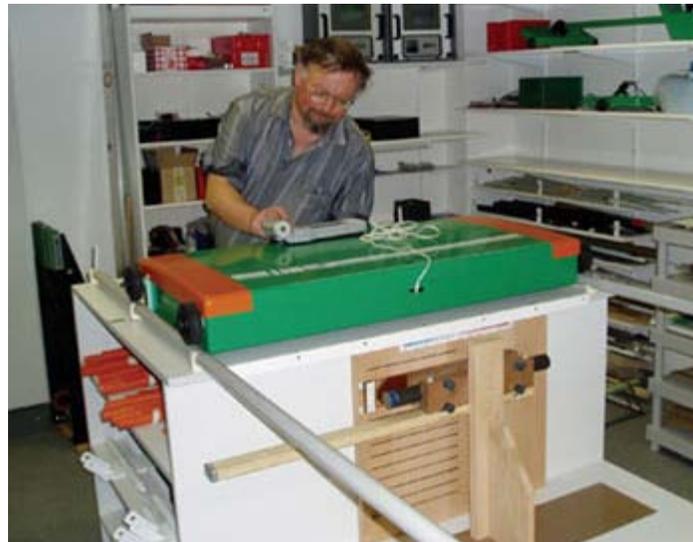
An engineer calibrates measurements at the MIT GmbH laboratory.

The results obtained are precise because of the meticulous calibration of MIT Scan-2 to each type of bar to be detected using the device. During calibration, measurements are taken over the entire range of bar positions and orientations to correlate the response signals to known bar positions and orientations. As the final step in calibration, the results are verified at the testing facility at the manufacturer's lab by comparing the MIT Scan-2 results to manual measurements.

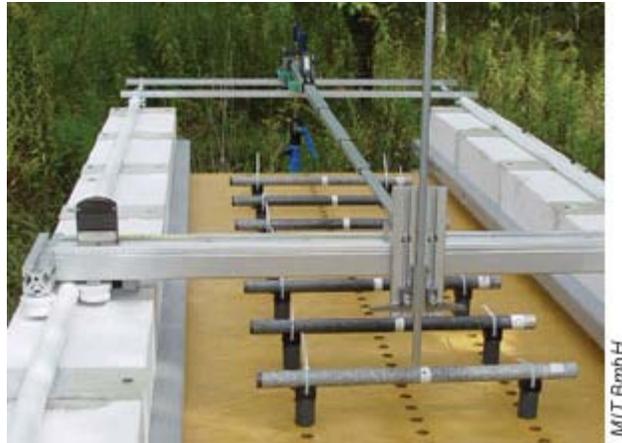
A dowel bar alignment is set up for a field validation at the testing facility.

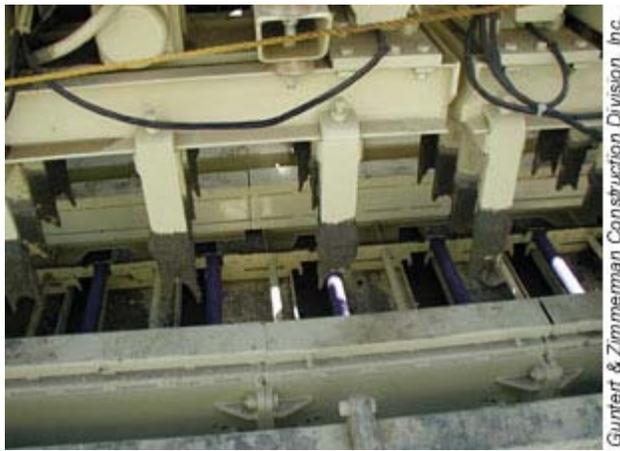
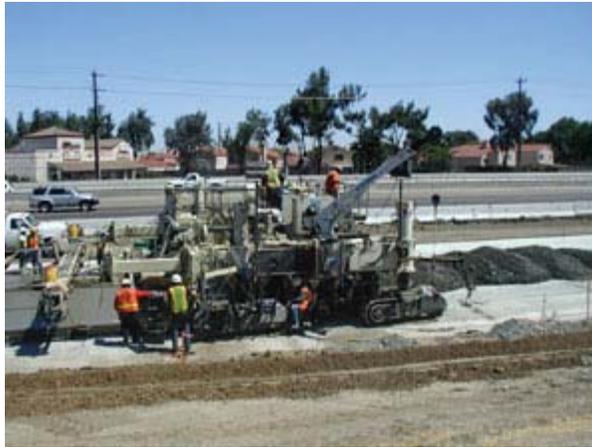
This closeup shows a dowel bar inserter. (Above) A construction crew is using a dowel bar inserter on this highway paving project.

For DBI construction, the critical factors are the proper adjustment of the equipment and concrete mix design. When using a DBI, the portland cement concrete (PCC) mix must be stable enough to hold the bars in place without displacing them during the paving operation.

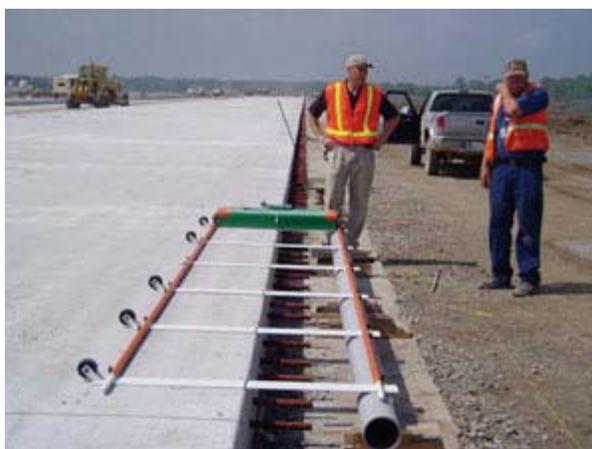
Workers prepare to use MIT Scan-2 to evaluate the dowel alignment in a new pavement joint.

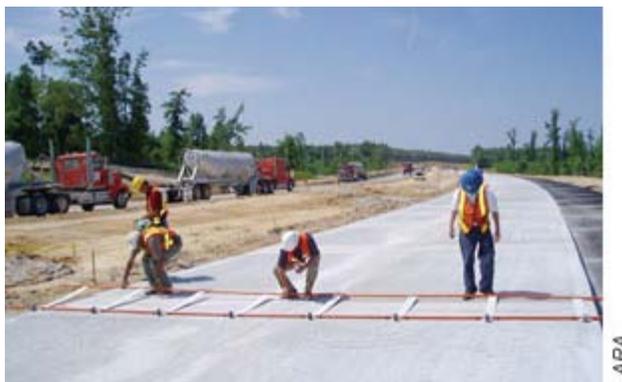
Three workers are using MIT Scan-2 on a U.S. 64 bypass construction project in Knightdale, NC.

In North Carolina, a contractor performing work on a U.S. 64 bypass project used MIT Scan-2 to gain approval to use the DBI construction method for a substantial savings in construction costs. On that project, the North Carolina Department of Transportation (NCDOT) used the device to monitor the dowel alignments to optimize the concrete mix design. When the PCC mix was optimized with assistance from the DBI manufacturer, an FHWA study showed that the resulting dowel bar alignment is among the best observed on any project, whether using a DBI or a dowel basket.
