## Field Demonstration of Magnetic Tomography Technology for Determination of Dowel Bar Position in Concrete Pavement

1. Report No. FHWA/VTRC 06-R40	2. Government Accession No.	3. Recipient's Catalog No.	
4. Title and Subtitle Field Demonstration of Magnetic Tomography Technology for Determination of Dowel Bar Position in Concrete Pavement		5. Report Date June 2006

June 2006  
VTRC 06-R40

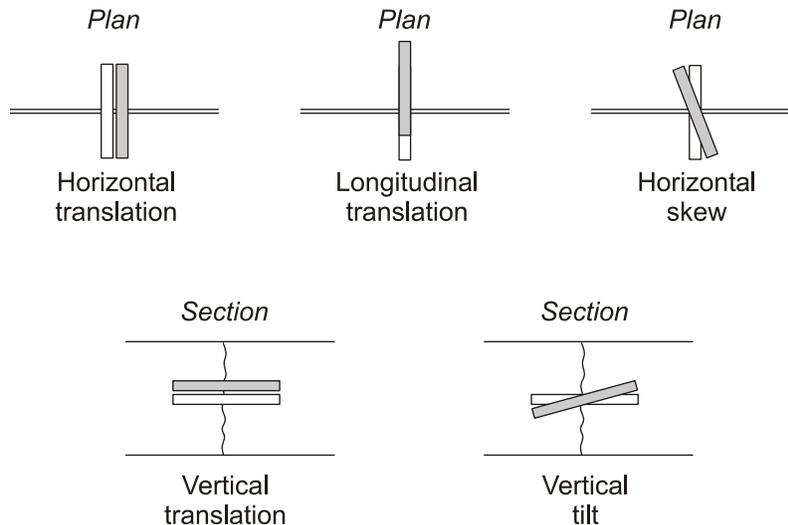
Dowel bars are placed in the jointed concrete pavement at mid-depth, parallel with both the pavement surface and the direction of travel; the center of the dowel is right below the joint. Tayabji<sup>1</sup> presented five categories of dowel misalignment, as shown in Figure 1.

Yu et al.<sup>2</sup> discussed the impact of misalignment of dowel bars, which can have a significant influence on the performance of a jointed concrete pavement. It can lock a joint, resulting in spalling and cracking near the jointed area, or it may create looseness around dowel bars, which would reduce the load transfer efficiency. Improper embedment depth may also

**Figure 1. Categories of Dowel Misalignments<sup>1,7</sup>**

contribute to spalling and cracking. Although, no comprehensive evaluation of the effect of dowel misalignment on pavement life or joint life is available, some researchers<sup>1,3</sup> suggested that joint damage may occur for a misalignment of more than 25 mm (1 in). Therefore, proper placement of dowel bars is important to ensure good performance of jointed concrete pavement.

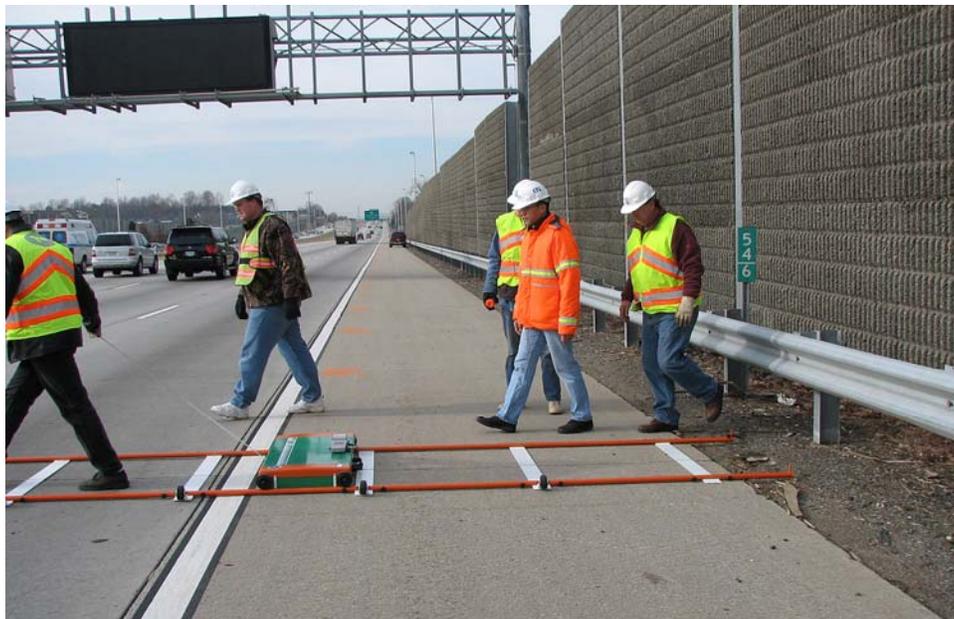
The MIT Scan-2 is a portable device with plastic guide rails as shown in Figure 3. The large box is the main sensor unit. Attached on the top of the main unit is a small computer that runs testing, stores data and performs field data analysis. The guide rail facilitates precise movement of the unit along the test joint at a constant elevation. The device generates real-time

Figure 3. MIT Scan-2 with Track Rails
